Investigation of Cold Cathode and RF  
Excitation

Long Life CO<sub>2</sub> Waveguide Lasers

Final Report  
for Contract AFOSR-82-0058

by  
U. Hochuli  
March 1983

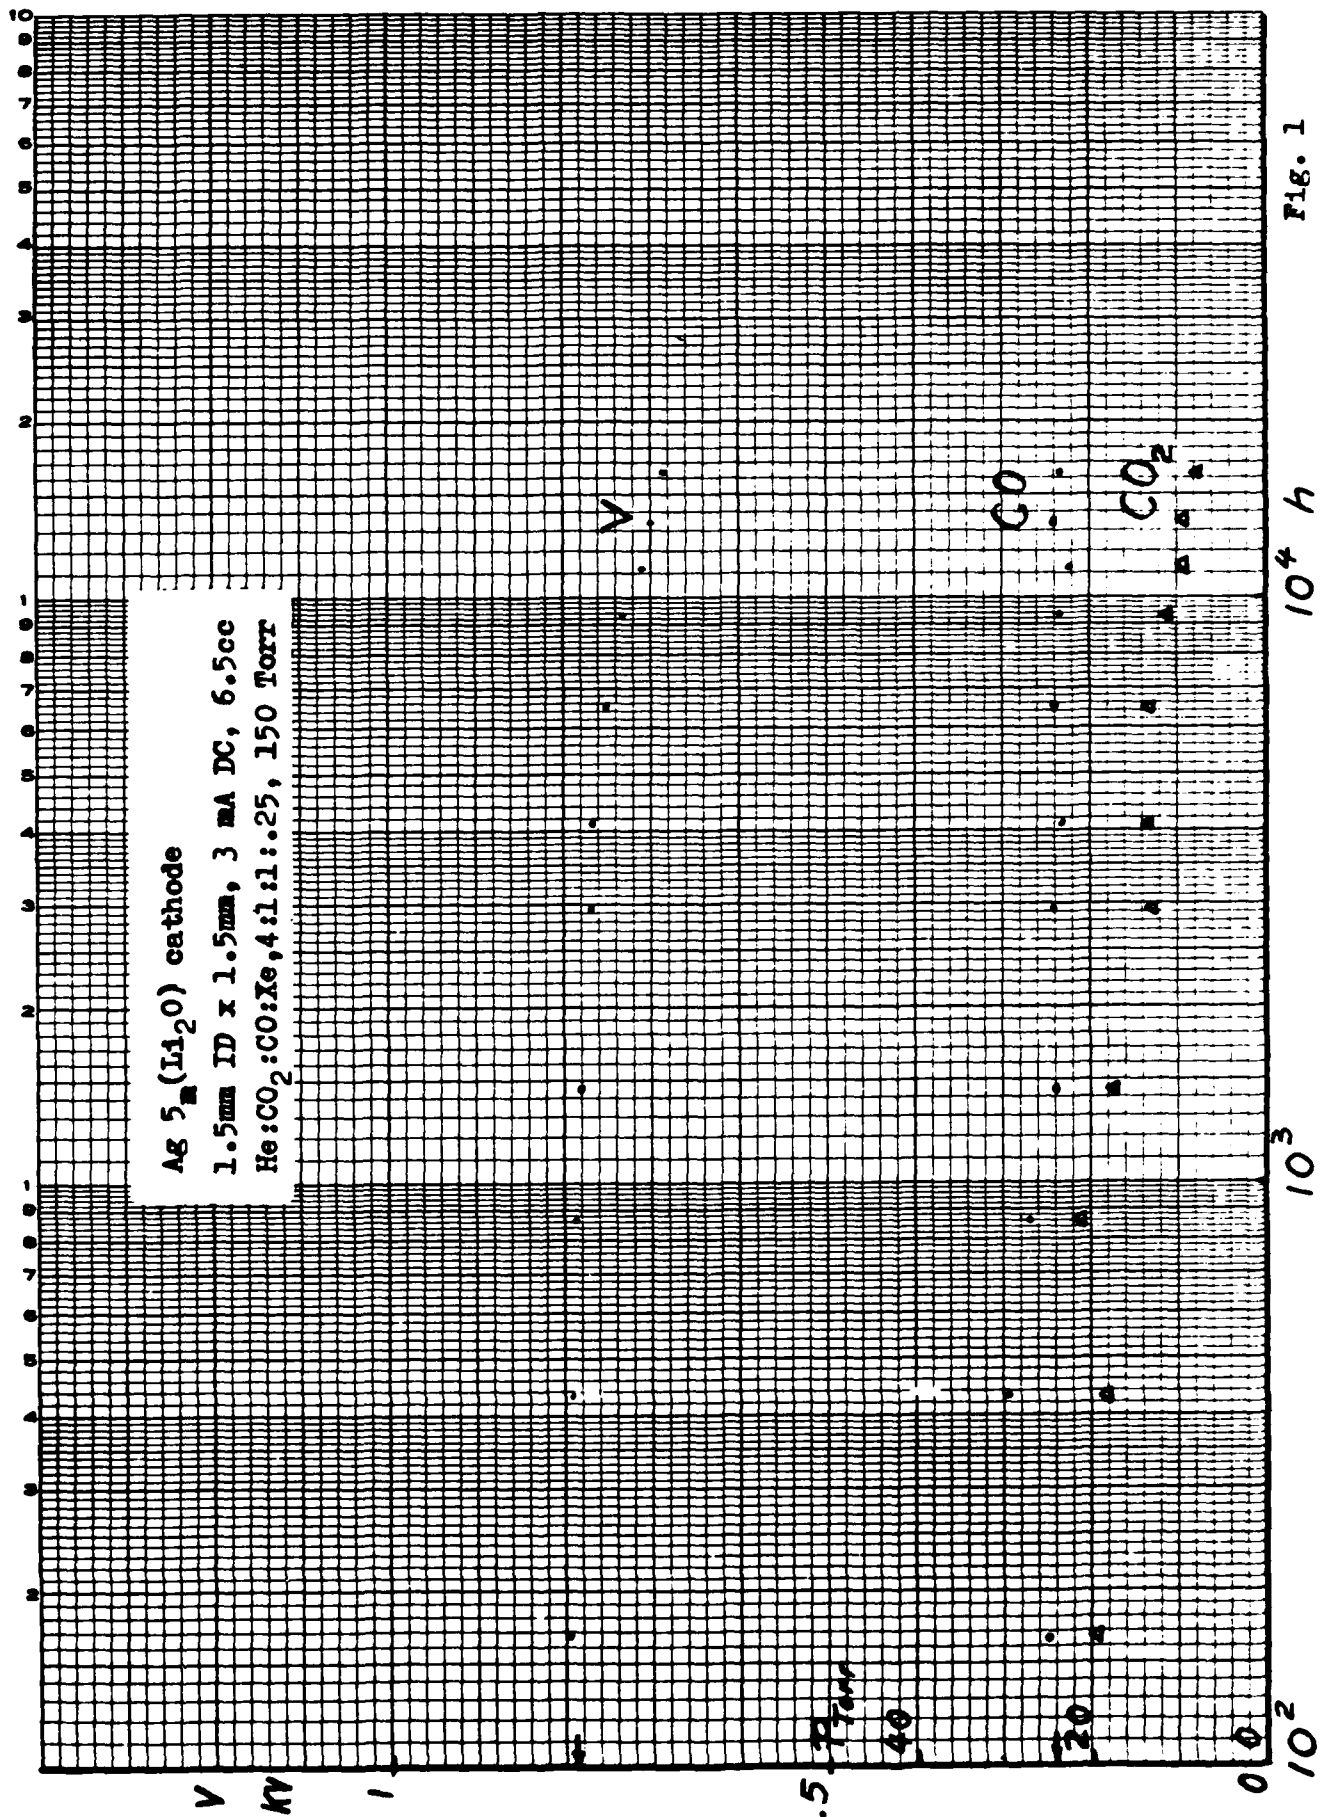
Fig. 1

CO and CO<sub>2</sub> contents, measured by infrared absorption spectroscopy, are shown in Figure 1. These results indicate that the Ag-Li compound cathode used may yield laser life of the order of 10<sup>4</sup> hours. This result alone does not qualify it as an outstanding cathode. The most pleasant and surprising aspects are its low sputtering rate and the absence of loose sputtering products outside of the cathode cavity. Figure A-2 shows the discharge tube after 20,000 hours of continuous operation. Its glass envelope reveals only a light film formed from sputtering products, with good wall adhesion and the sputtershield is quite clean. Figure A-3 exhibits the cathode assembly and the anode of the dissected discharge tube. The deposits visible on the anode sheet indicate that material transport from cathode to anode had taken place. Figure A-4 shows the cathode assembly, cut in half along the cathode axis. The cathode cavity itself is covered by a burr and can not be seen. The interesting detail, clearly visible here, is the erosion that took place in the throat of the sputtershield. The throat, originally a cylindrical hole, now shows the standing wave pattern caused by plasma oscillations. Regrinding to remove the burr resulted in a cut that is not parallel anymore with the cathode axis but opened the cavity for inspection as shown in Figure A-5. The original shape of the cavity bottom duplicated the drill point used to machine it. The bottom is now well rounded and the removed material has relocated and filled-in the top edge of the cavity. This process apparently took place without forming loose sputtering products.

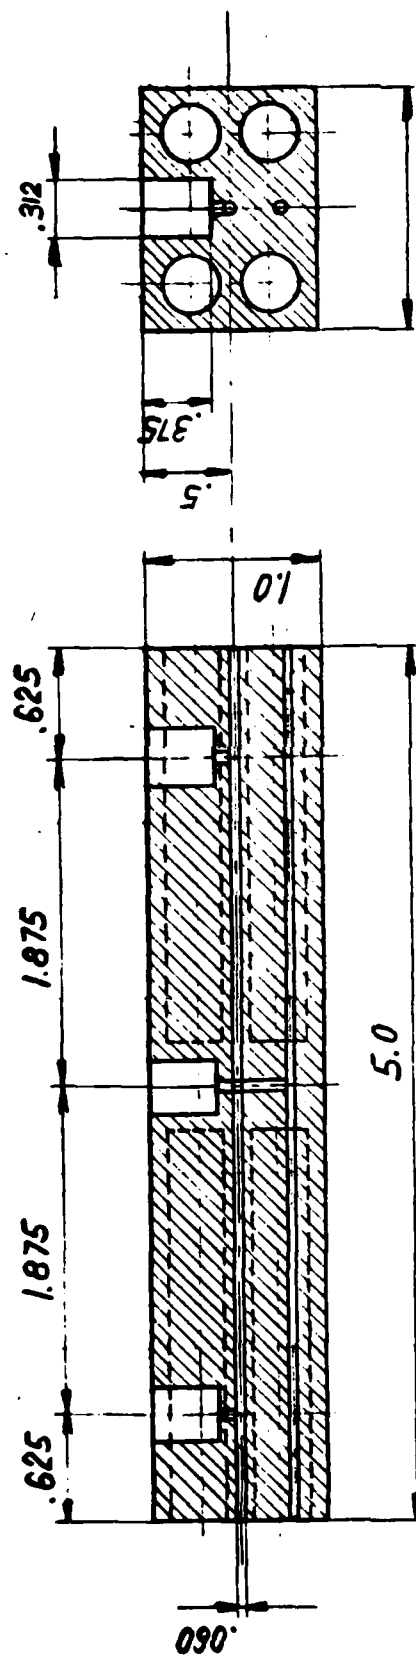
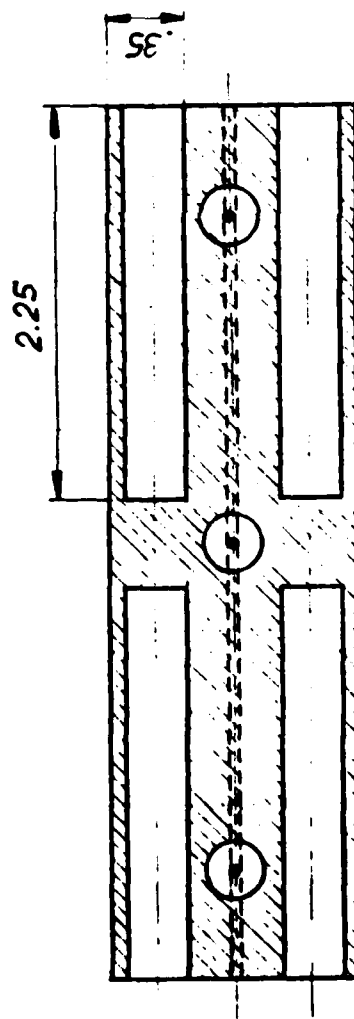
Fig. 2

LASER STRUCTURE  
(BeO)

Two of these structures, shown in Figure A-1 (Crossection shown in Figure 2) were assembled and put on life tests. The first laser had one Pt anode at each bore end and a common 4mA Ag-Li compound cathode in the center. Life test results, shown in Figure 3, indicate a disappointingly low life of 1900 hours for the first run. The laser was then evacuated and refilled for a second test. The initial power output for the second test was slightly higher than for the first test, an indication that so far no serious mirror degradation had taken place. Laser life turned out to be even shorter, only 450 hours. We discovered later that the laser envelope had developed a vacuum leak at one of its seals. Inspection of the cathode indicated fairly heavy erosion. In one place the cathode spot had produced a hole clear through the cathode wall out to the sputtershield. Unfortunately we do not know if the cathode current of 4mA was excessive or if the presence of air was responsible for this result. We felt that this test had failed and no further analysis was made on this laser.

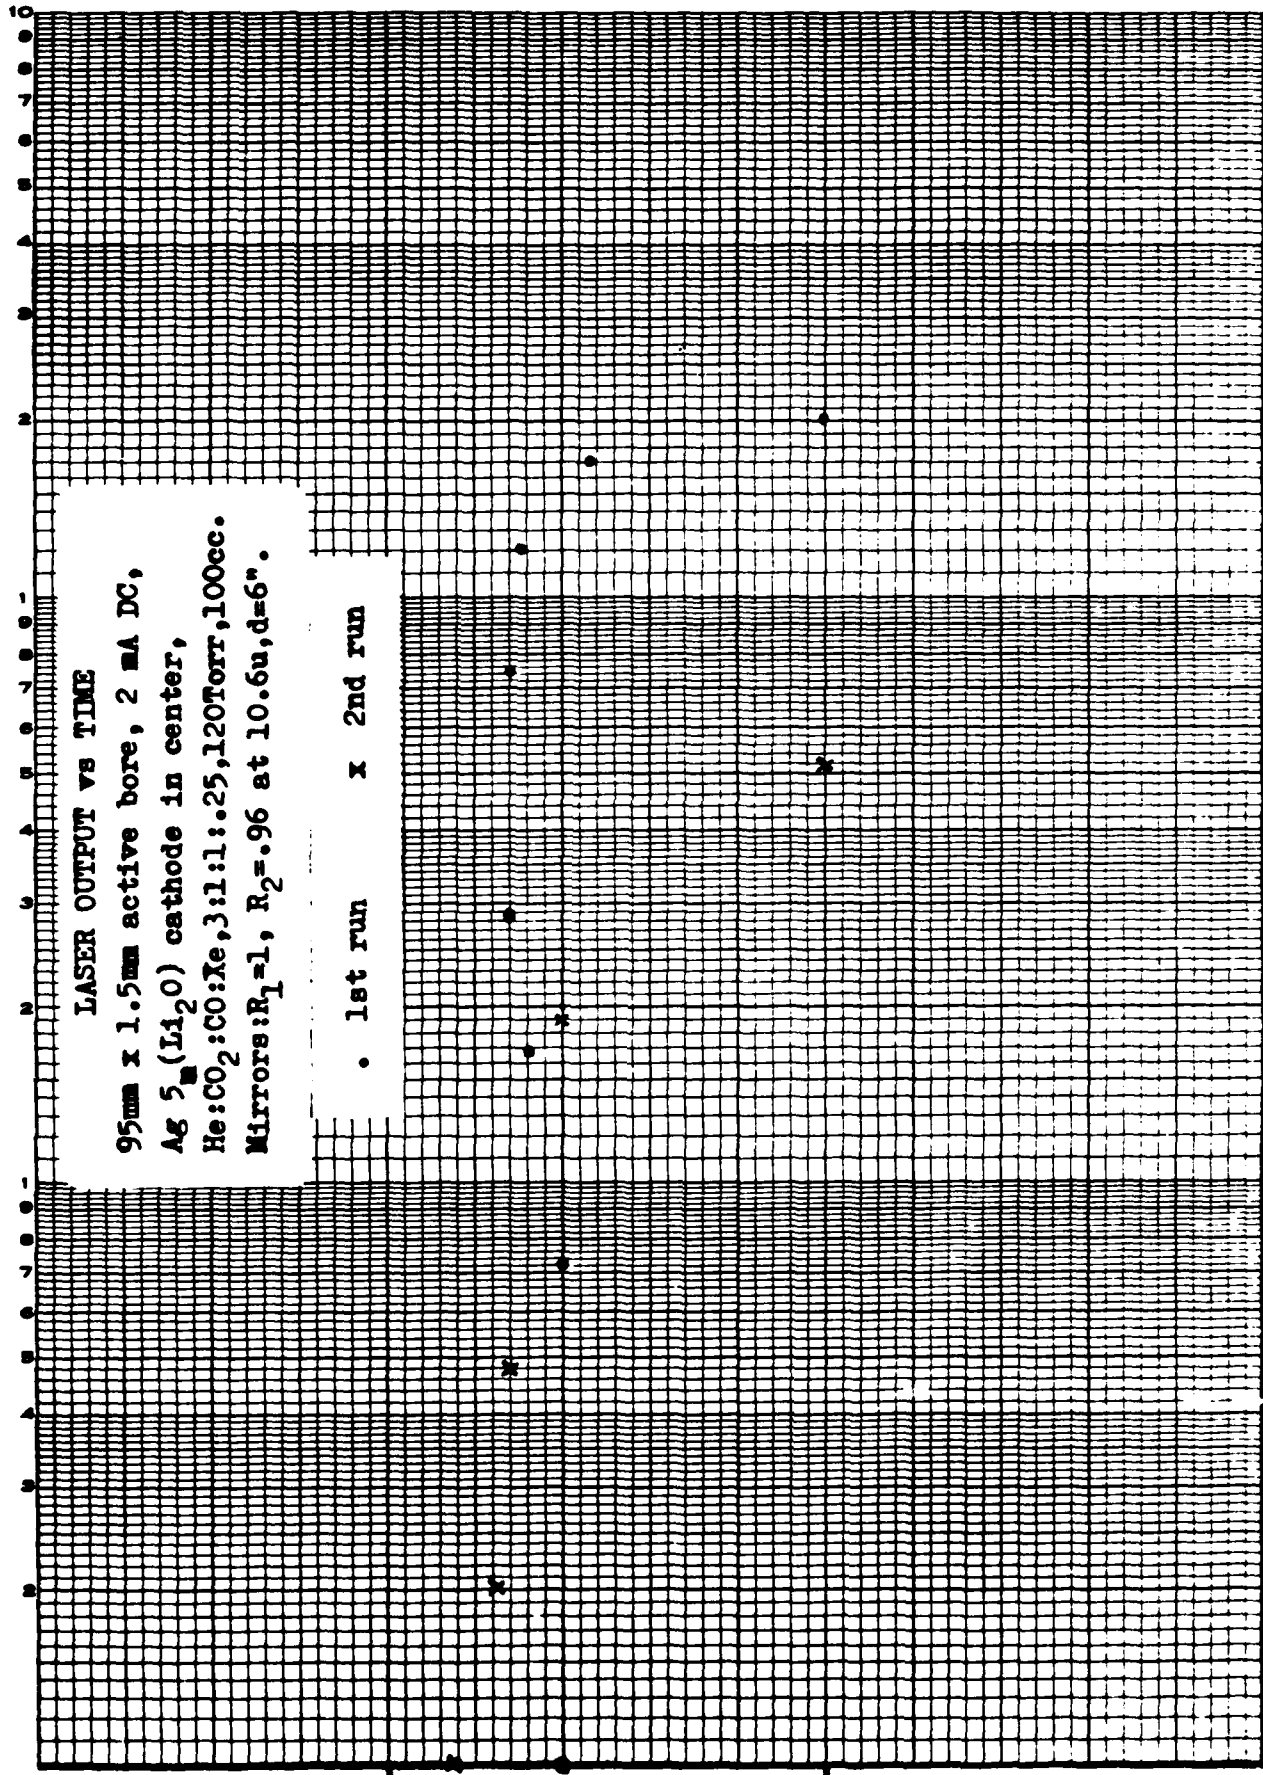
LASER OUTPUT vs TIME

95mm x 1.5mm active bore, 2 mA DC,  
Ag  $5_{\text{m}}$  ( $\text{Li}_2\text{O}$ ) cathode in center,  
He:CO<sub>2</sub>:CO:Xe, 3:1:1:25, 120 Torr, 100 cc.  
Mirrors:  $R_1=1$ ,  $R_2=.96$  at 10.6  $\mu$ ,  $d=6"$ .

. 1st run      x 2nd run
